CAMPUS PARK PROJECT

APPENDIX M

DRAFT FINAL SUBSEQUENT
ENVIRONMENTAL IMPACT REPORT

FINAL ENVIRONMENTAL IMPACT REPORT PHASE I ENVIRONMENTAL SITE ASSESSMENT AND LIMITED CHEMICAL RESIDUE SURVEY INFORMATION FOR THE READER

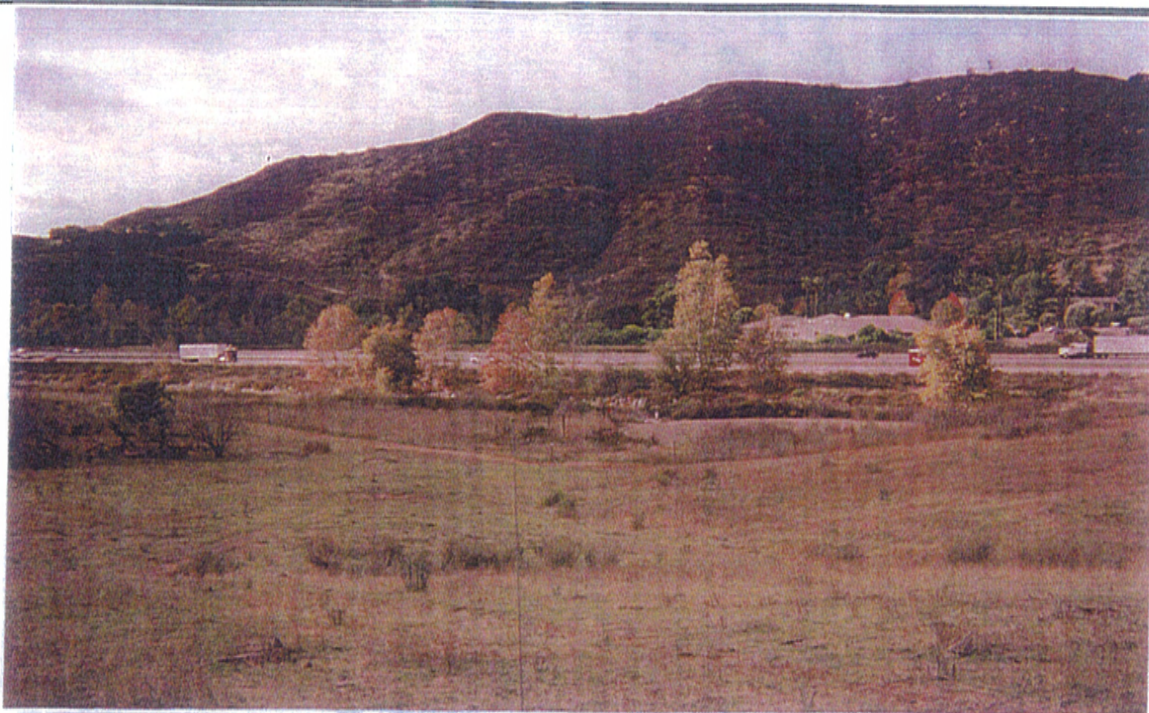
1. Typical property conditions within northern portion of Parcel B. Note, cul-de-sac end of Pankey Road visible in right background. View is to the west, towards I-15 Freeway visible in background.

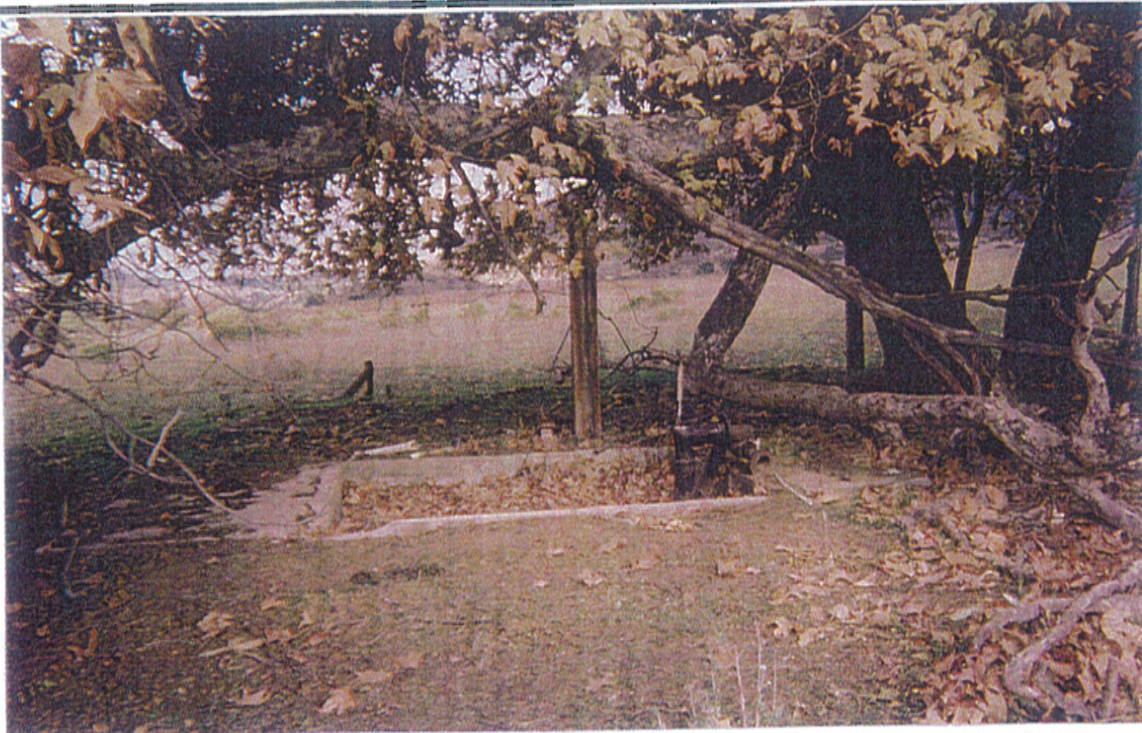
3. Abandoned water well and concrete foundation encountered within west central portion of Parcel B. Metal pipe behind cellar delineates location of water/irrigation lines from well. View is to the north.

- Field observations and agency records/files indicate that there are at least three water wells onsite. Recent field observations indicate that the two wells observed on Parcel B are not in operation. Wells on Parcel B will require proper abandonment, following State of California guidelines. Guidelines dictate that a state registered water well contractor shall abandon water wells. GSI can coordinate these services upon request.

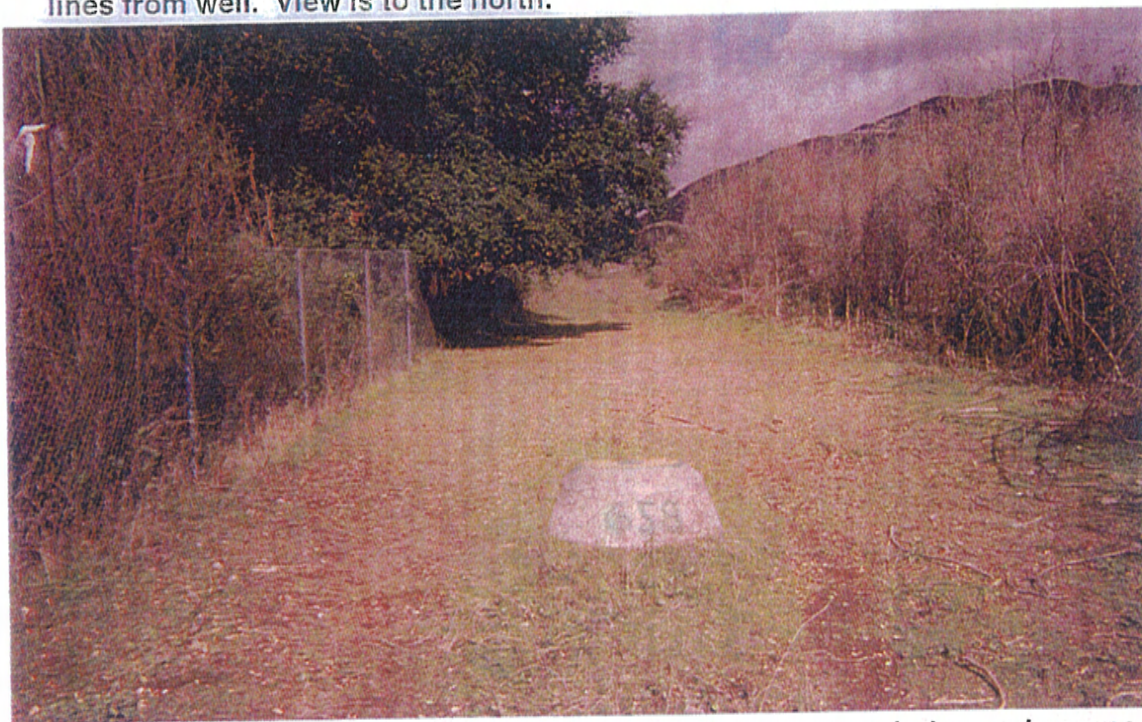
4. Rainbow Municipal Water District easement with sewer manholes and access road along west edge of Parcel B. Fence in left photo delineates I-15 easement. View is to the north.

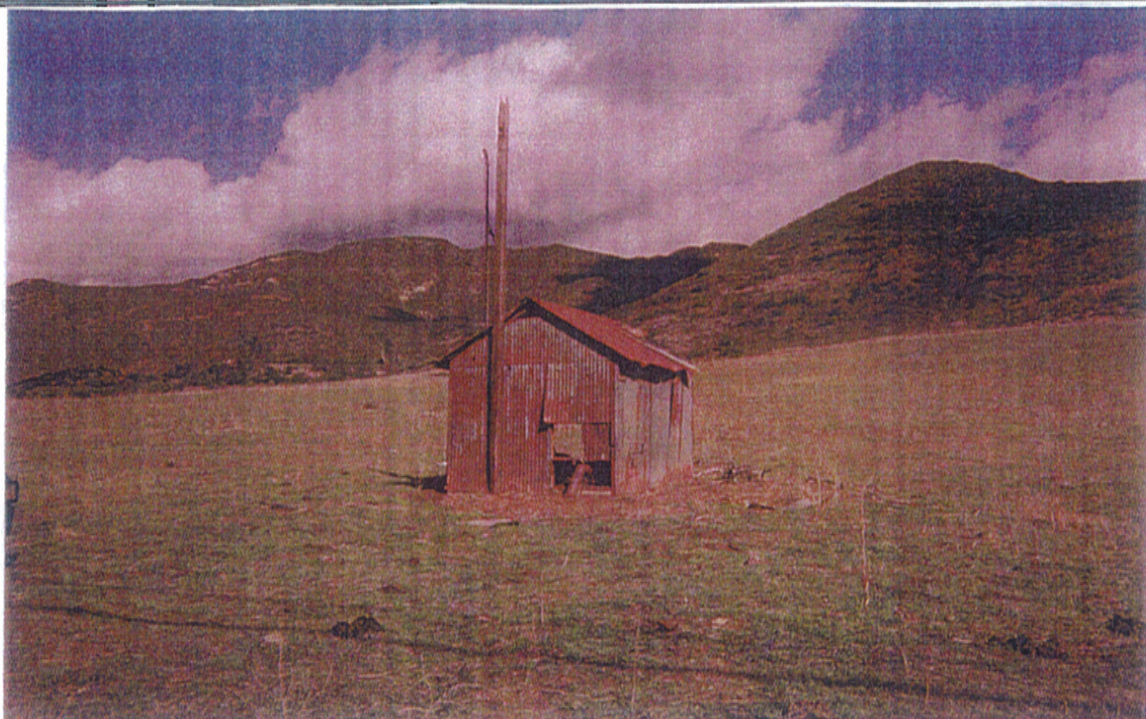
5. Abandon water well pump-house located in northeasterly section of Parcel B. Background conditions are typical for grazing areas of property. Hills in left background are a part of Parcel A. Hills in right background are not a part of subject property. View is to the northeast.

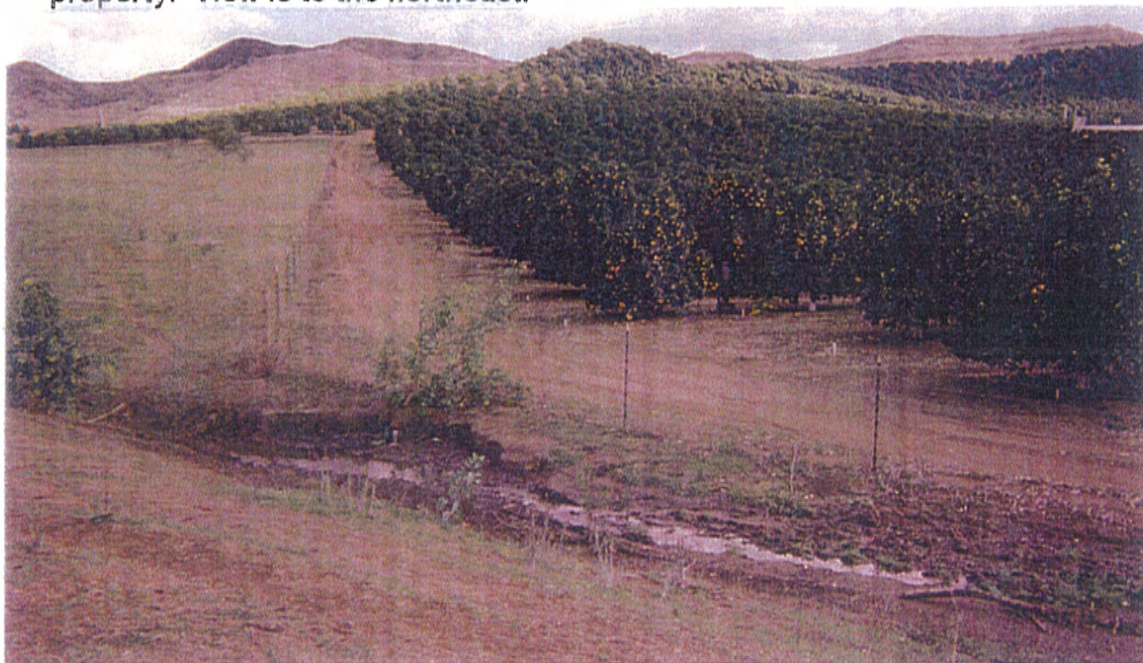
6. Surface water encountered in creek along east central portion of Parcel B. Note water flow from small pipe in creek to the right of fence corner. Citrus orchard in right photo is offsite. View is to the east.

- Based upon laboratory test results of the water sample collected onsite, concentrations of nitrate exceed the MCL for drinking water and the water quality objectives for surface water. As a result, water discharged onto the property may be considered a recognized environmental condition; however, due to the current land use as cattle grazing, this condition does not appear to be a significant issue at this time. Considering the apparent offsite source of water (from the east), the most prudent method of mitigation would be to eliminate the discharge source.

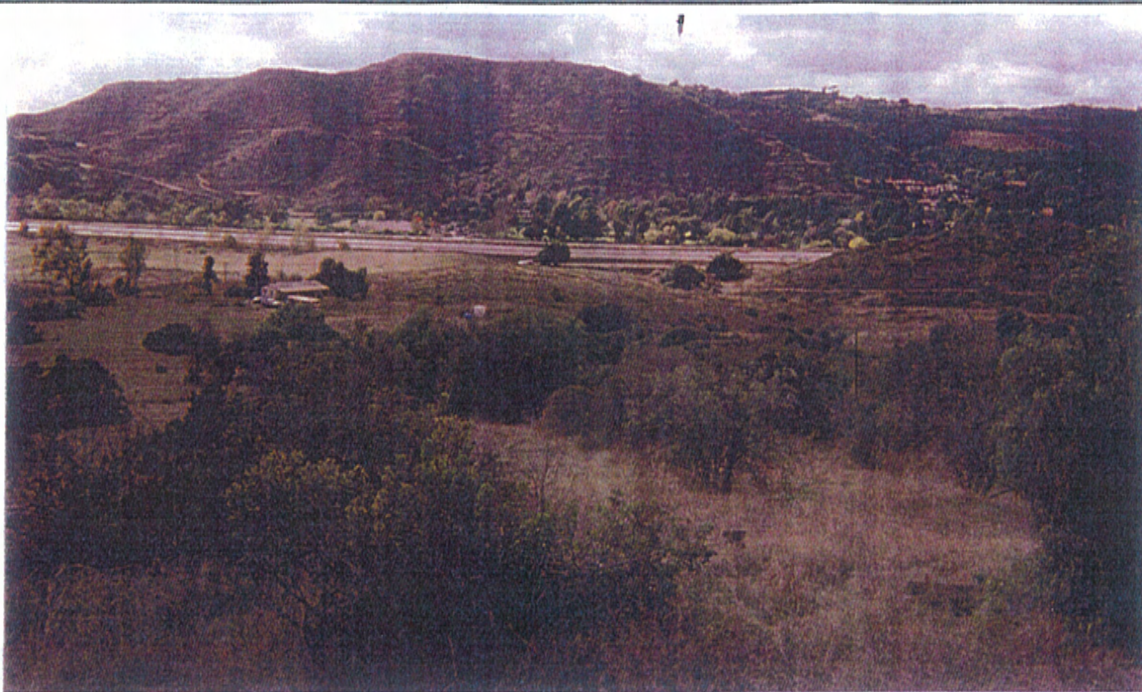
7. Typical property conditions observed within Parcel A. Noted residential trailer in left background, with white above ground tank associated with water well situated to the right of structure. Note wooden power poles in canyon in right photo. View is to the southwest, with I-15 Freeway in background.

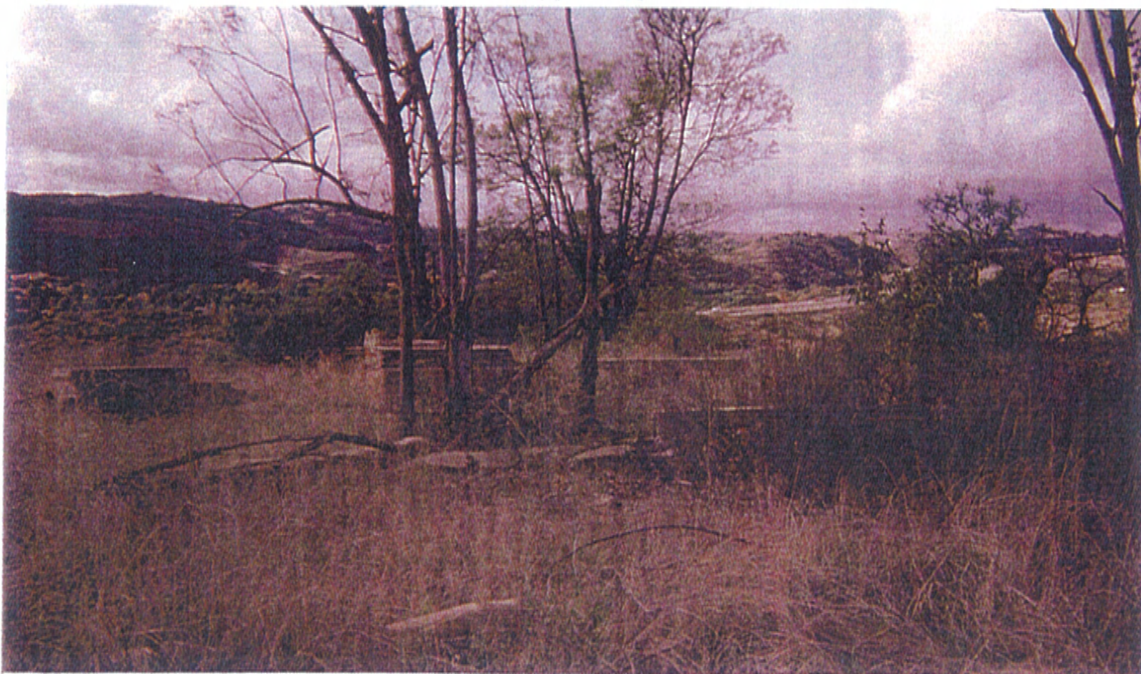
8. Concrete foundations and stemwalls encountered on ridge in southeastern section of Parcel A. View is to the west.

- Based upon the historical presence of farm-support type structures on or directly adjacent to the subject property, there is a possibility that onsite sewage disposal systems (i.e., septic tank[s], seepage pits, and/or leach lines, etc.) are present on the property. Although not considered a hazardous waste, any buried septic systems should be properly removed or abandoned following health department guidelines.
